Manhole Inspection Summary

Manhole # S13K__003MH

Inspection ☐ Is Incomplete Rating: **3) Fair**

Insp Date: **7/1/09 11:46 AM**

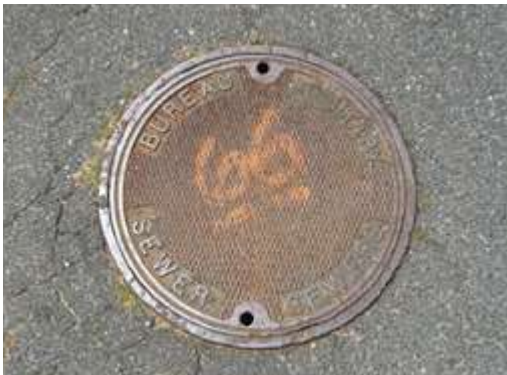
cover view

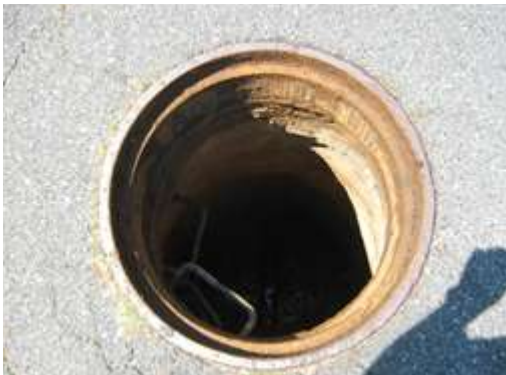
Frame View

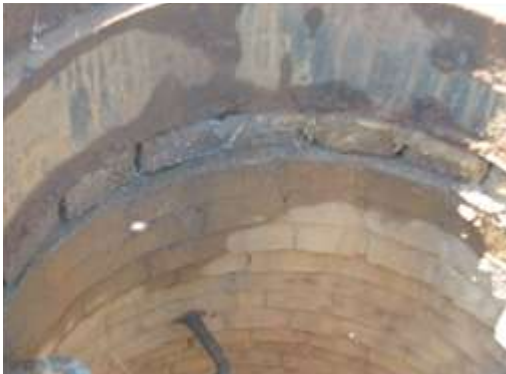
Defect 1

Condition: ☐ Sound ☐ Cracked ☐ Root Intrusion ☒ **Loose Brick** ☐ Deteriorated

Infiltration: ☐ None ☐ Joint ☐ Cracks ☒ **Mortar** ☐ Roots ☐ Wall

chimney infiltratin from missing mortor

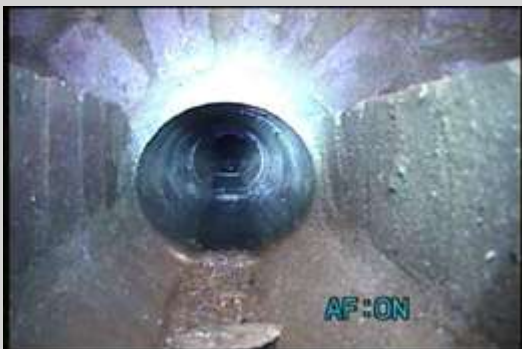
6 O'Clock Inflow

6 O'clock pipe in appears to be service connection for the abandoned building to the north-east.
